NBSIR 73-150

Examination of Compressor Parts from Allison Engine from Fairchild Hiller Helicopter

Failure Analysis Report

Fairchild Hiller FH1100, N590FH, helicopter, North Bend, Washington, July 19, 1972. NTSB accident no. SEA 73-A-S001.

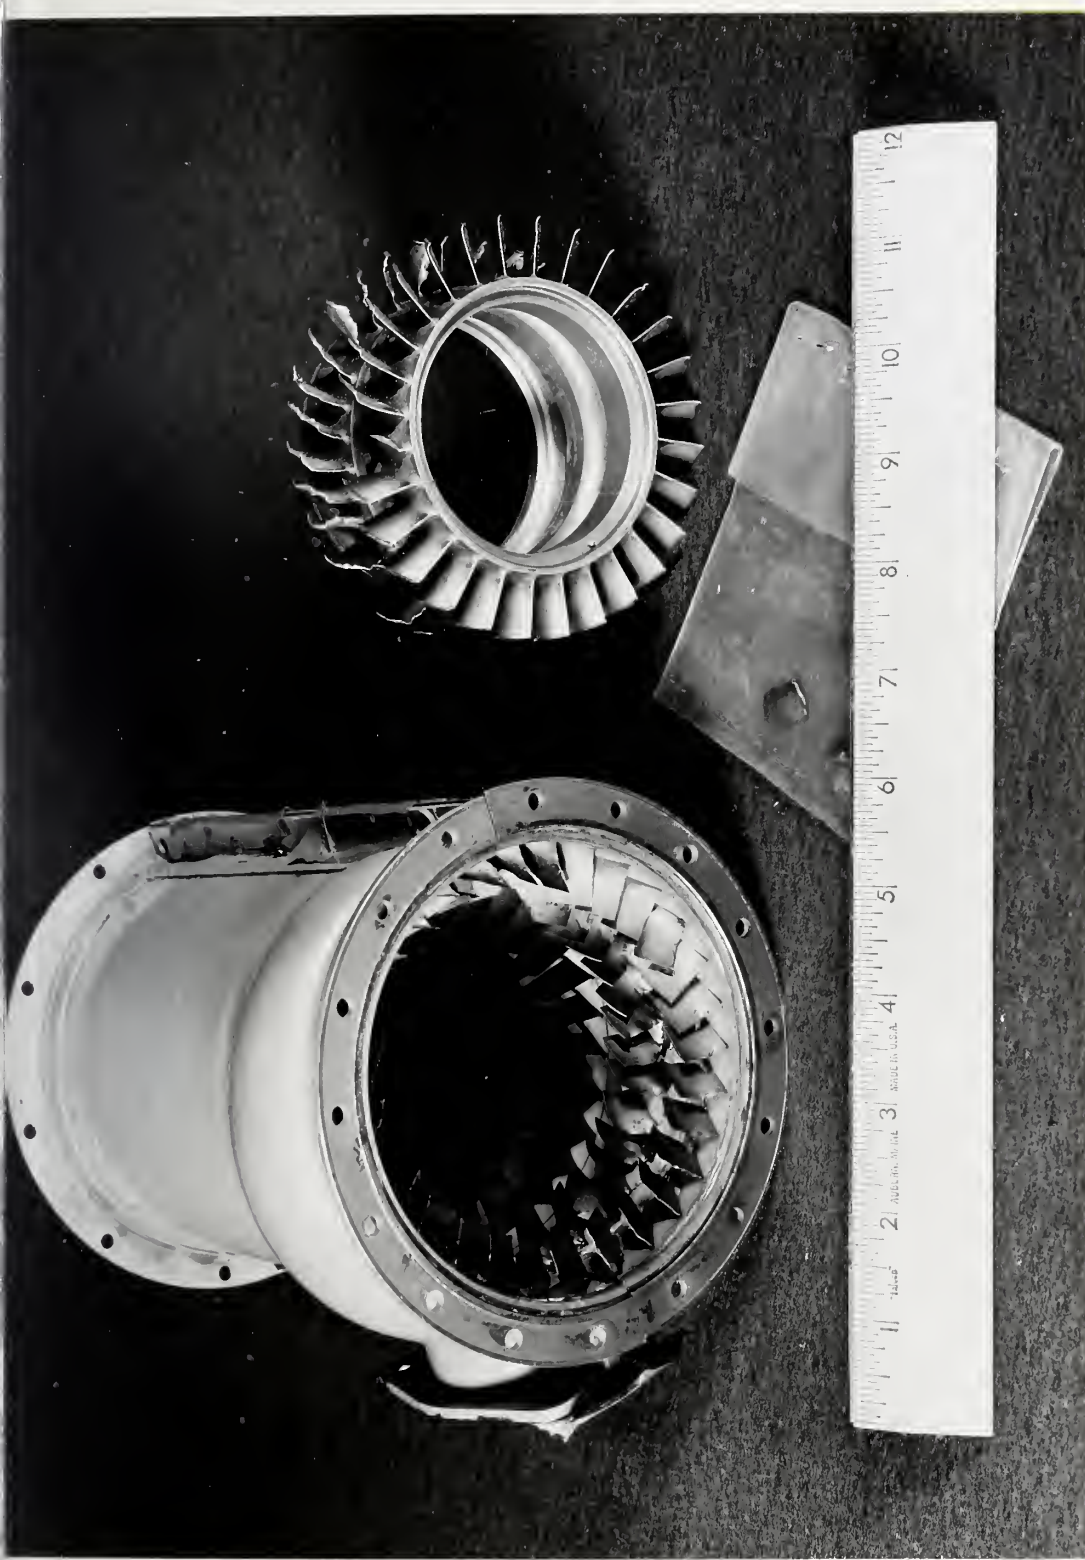
The parts are shown as received in figure 1.

Figure 1. Compressor case, fifth and sixth stage wheel assembly, and a fragment of a compressor blade and a stator blade (in plastic envelope) as received. X 2/3

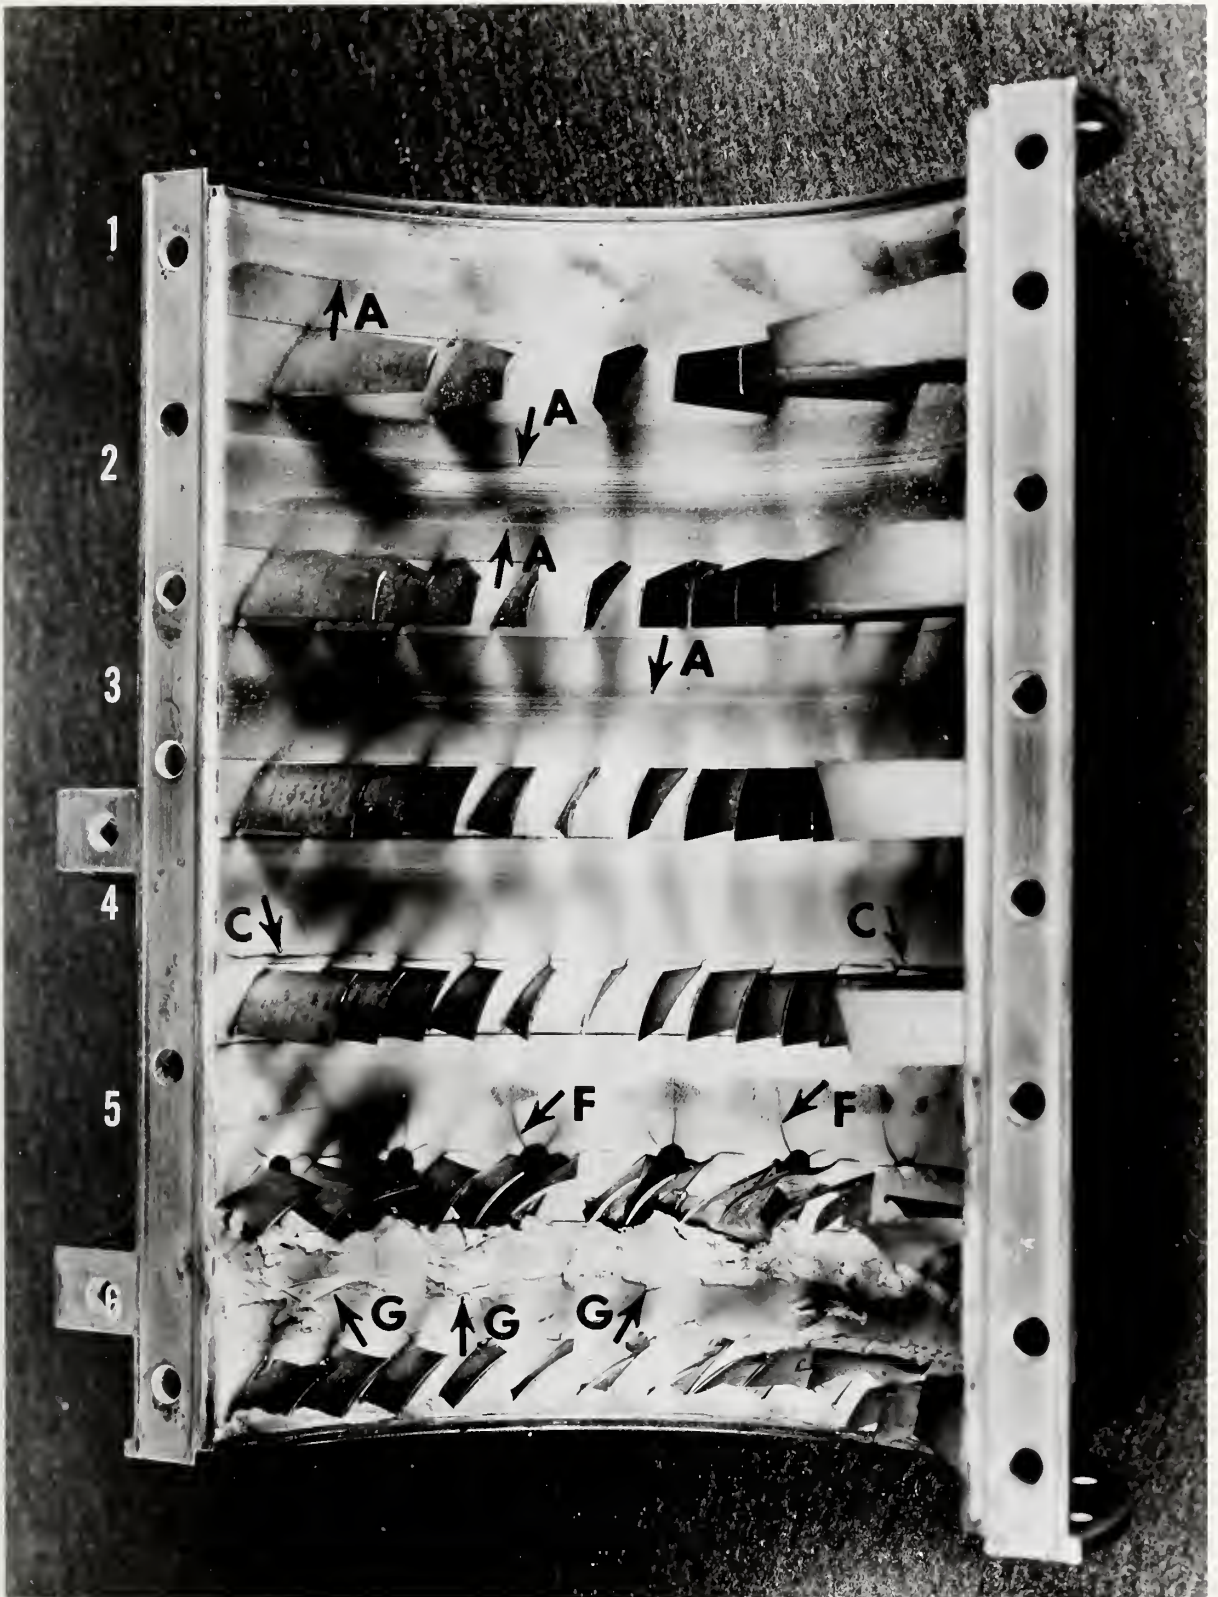
Figure 2a. Half of open compressor case. X 1

There was considerable damage inside the compressor case both to the case lining and to some of the stator blades. The two halves of the open compressor case are shown in figures 2a and 2b. The lining on the inside of the case appears to have been wiped between the end of the case and the first stator blade stage, and between the first and second, second and third, third and fourth, and fourth and fifth stator blade stages. These regions would be opposite the first, second, third, fourth, and fifth stages, respectively, of the compressor blades when the compressor is assembled for operation. In figure 2, wiped areas generally appear darker than adjacent unwiped areas. Some examples of wiped areas are indicated by arrows A in figures 2a and 2b. One wiped area between stator blade stages one and two is shown at higher magnification in figure 2c.

Between the third and fourth stator blade stages, the lining was cracked and had begun to pull away from the case (arrow B, figure 2b). On the half of the case shown in figure 2a, there are cracks in the lining at the edges of some of the stator blades, and there are two cracks parallel to the fourth stage (arrows C, figure 2a). One of these cracks spans seven blades. Varying amounts of the lining are missing between several pairs of the fourth stage blades exposing the metal case (arrows D, figure 2b).

Severe damage is exhibited by the case lining between the fourth and fifth, and the fifth and sixth stator stages. In some areas, the bare metal case was exposed (arrows E, figure 2b). Where the bare metal is not exposed, there are a number of cracks (arrows F, figure 2a) in the lining adjacent to the fifth stage blades, and the lining had been gouged and/or galled in a number of places (arrows G, figures 2a and 2b).

The apparent wiping of the compressor case lining opposite the first, second, third, fourth, and fifth compressor wheel stages appears to have been caused by contact with the blades of the rotating compressor wheel. Several conditions may have permitted the wiping action, such as 1) the compressor wheel was oversize, 2) the compressor wheel bearings were worn or off center, allowing the wheel to wobble, 3) the axes of the case and the wheel were not coincident, or 4) the compressor case was undersize, or not truly cylindrical. It would seem that the most probable of these four conditions would be wobbling of the wheel.

Arrows A indicate examples of areas where the case lining had apparently been wiped by the compressor blades.

Arrows C, figure 2a, indicate cracks in the lining parallel to and adjacent to the fourth stage stator blades.

Arrows E, figures 2a and 2b, indicate examples of areas between the fourth and fifth stator stages where the lining is missing.

Arrows F, figures 2a and 2b, indicate examples of cracks in the lining adjacent to the fifth stage stator blades.

Arrows G, figures 2a and 2b, indicate examples of gouged or galled areas in the case lining between the fifth and sixth stator stages.

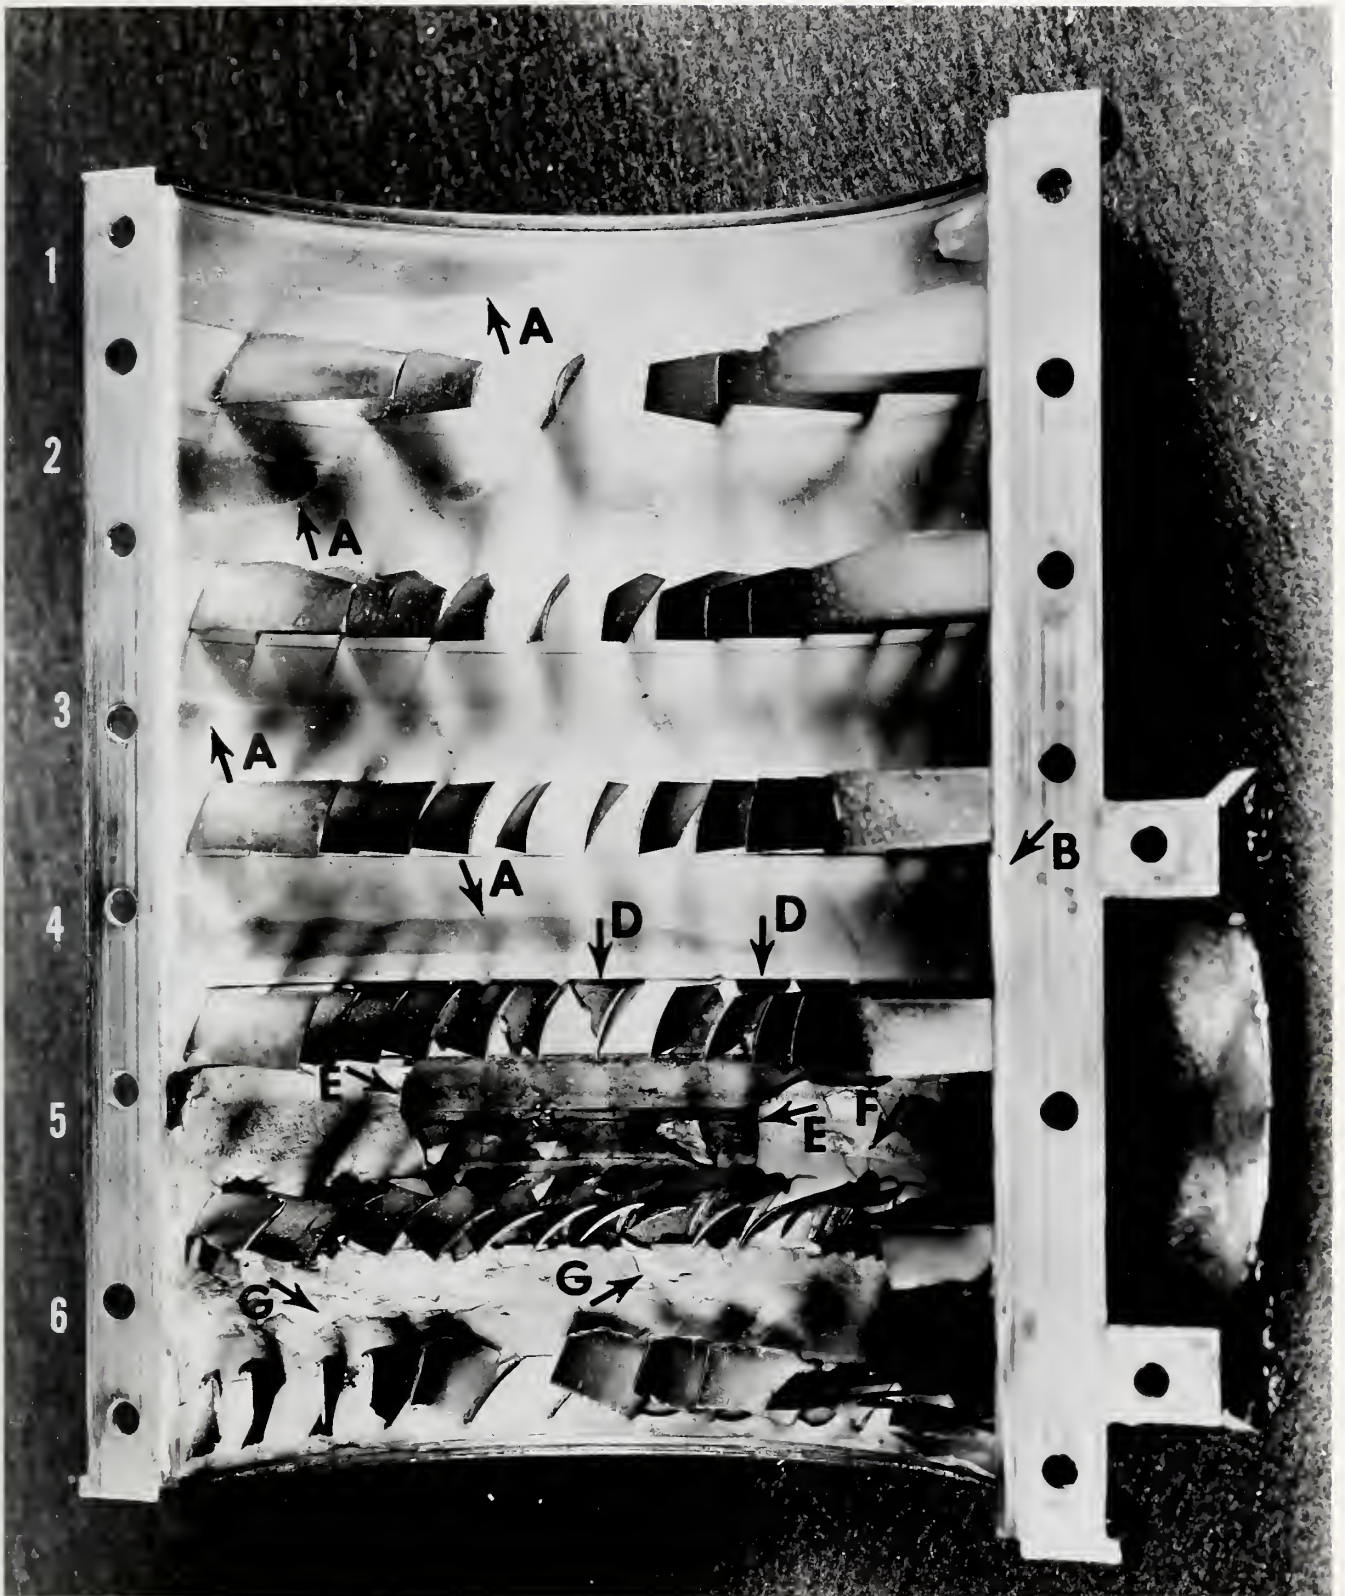
Figure 2b. Second half of open compressor case. X 1

Arrow B, figure 2b, indicates where the lining is cracked and is pulling away from the case.

Arrows D, figure 2b, indicate examples of areas where the lining is missing between the blades of the fourth stator stage.

Figure 2c. Example of wiped area of case lining between the first and second stator stages at higher magnification than in figure 2b. X 4

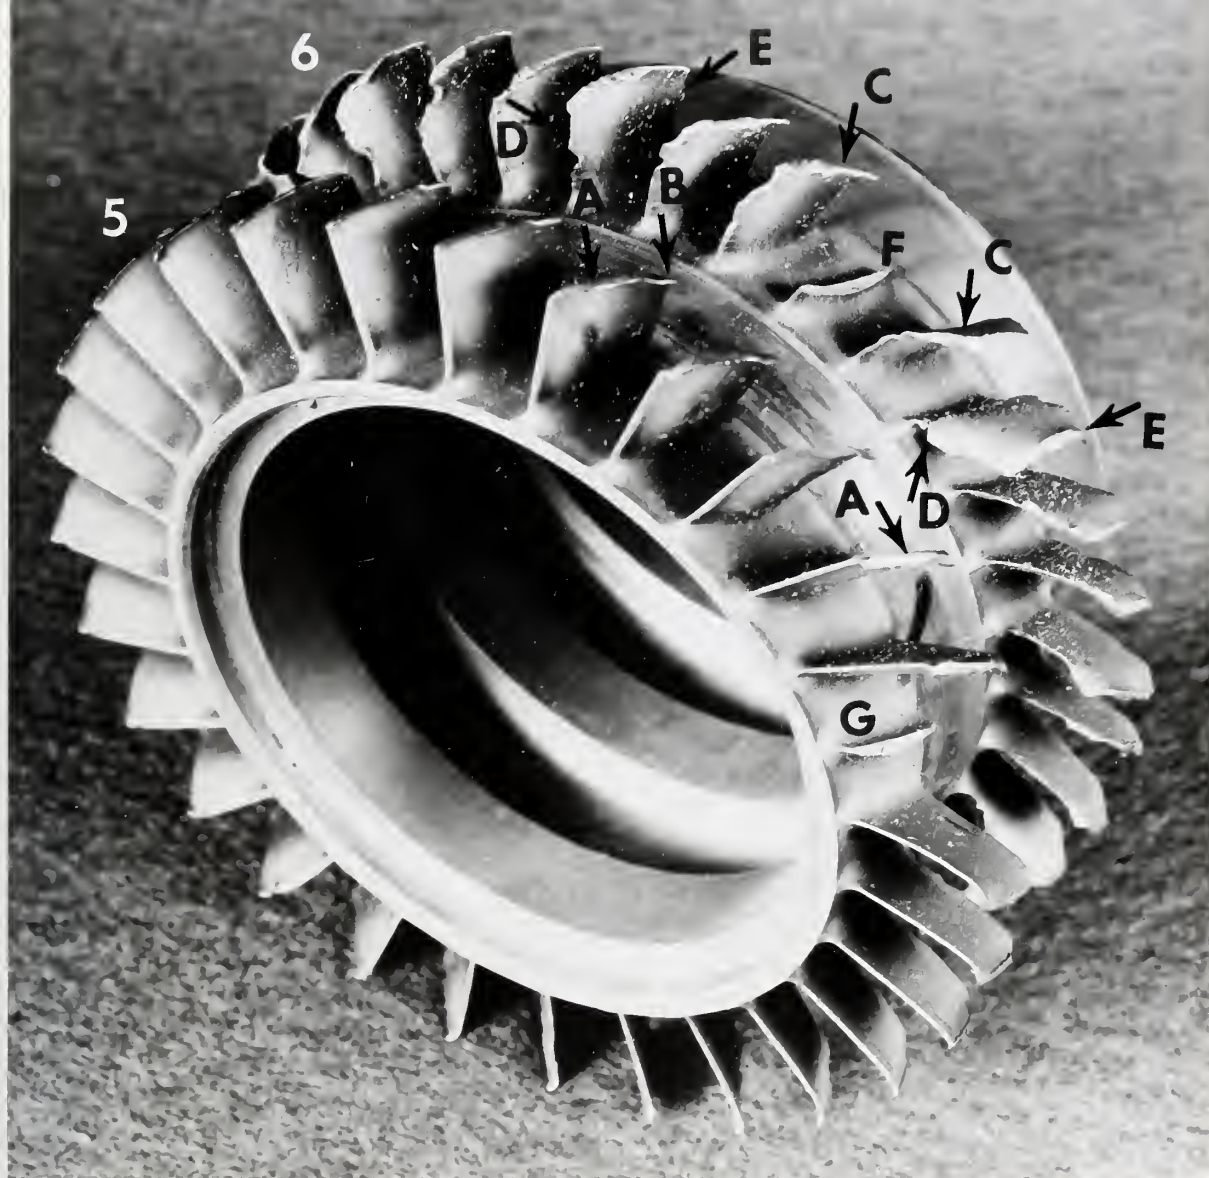
Figure 4. Fifth and sixth stage compressor wheel assembly as received. X 1

All of the compressor blades of the fifth and sixth stages of the wheel assembly were damaged. Much of this damage can be seen in figure 4. The ends of the fifth stage blades were wiped or "smeared" (arrows A, figure 4), and about 1/16 inch of the sides of the blades adjacent to the blade ends and facing the sixth stage was smeared. This can not be seen in figure 4, but arrow B indicates the location of the damage on one of the blades. The damage was more severe to the sixth stage blades than to the fifth stage blades. The ends were smeared (arrows C, figure 4). There was smearing and tearing on the sides of the blades facing the fifth stage (arrows D, figure 4), and there was some smearing and bending on the other sides of the blades (arrows E, figure 4). In addition, there was one completely fractured blade on the fifth stage, and two completely fractured blades on the sixth stage. Two of these are indicated by the letters F and G in figure 4. One fractured blade from the sixth stage cannot be seen in the figure. It is designated H.

The numbers in the upper left indicate the stage number. Arrows A indicate examples of wiping or smearing of the fifth stage blades.

Arrow B indicates the location of smearing on the side of one of the fifth stage blades.

Arrows C indicate examples of smearing of the ends of the sixth stage blades.

Arrows D indicate examples of tearing on the sides of the sixth stage blades.

Arrows E indicate examples of bending and smearing on the sides of the blades opposite to that indicated by arrows D.

F indicates a fractured sixth stage blade.

G indicates a fractured fifth stage blade.

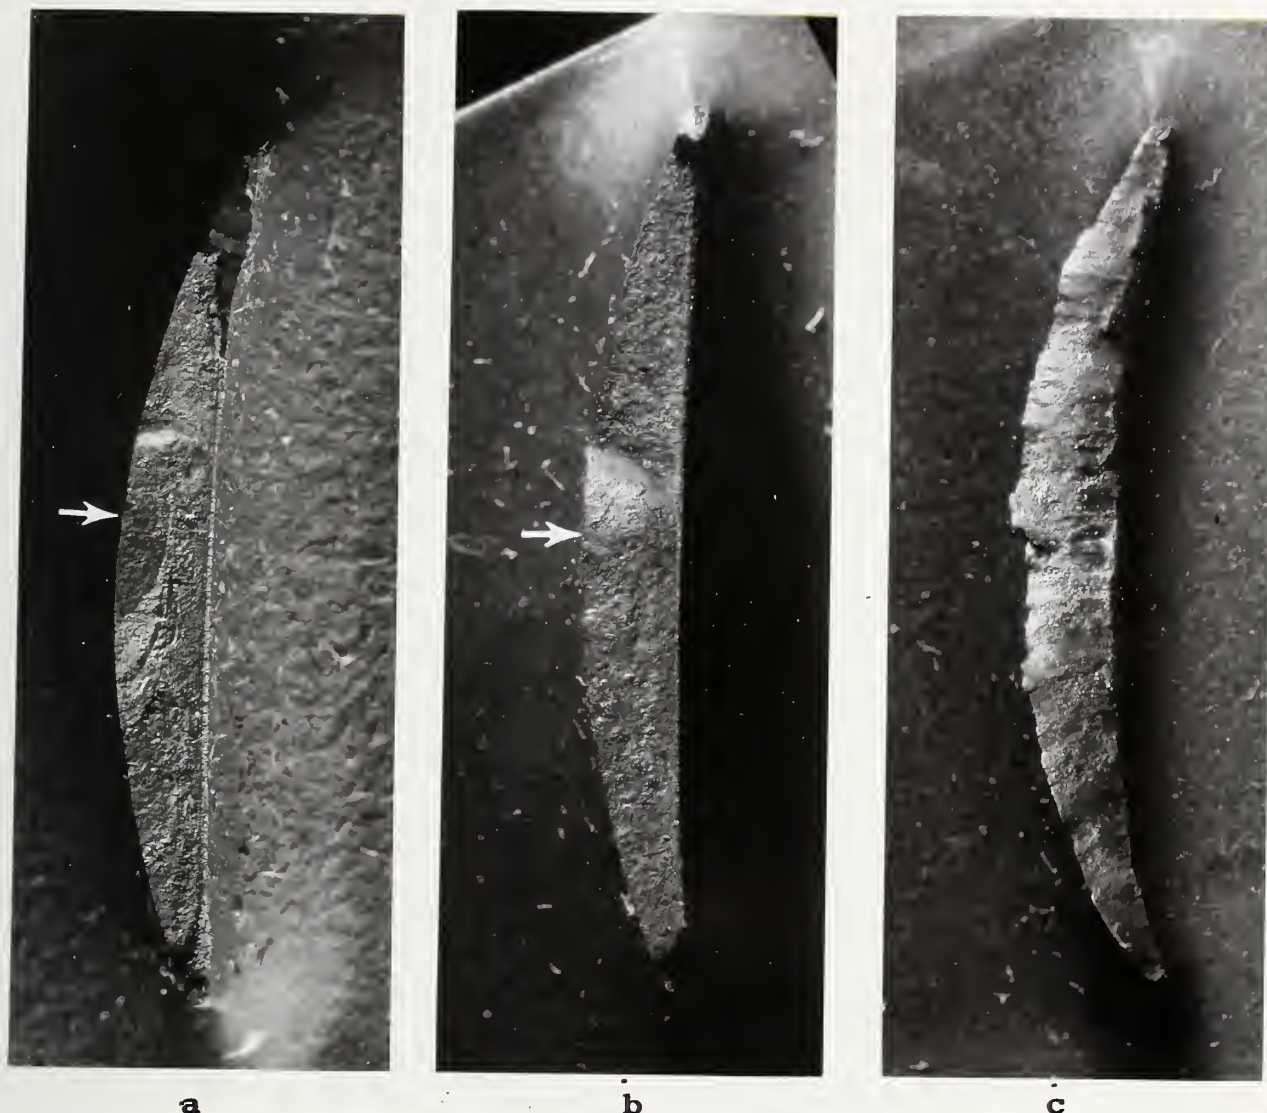
The fracture surfaces of the three completely fractured compressor blades were examined. The fracture surfaces of blades F and G (location indicated in figure 4), which are shown in the photomacrographs of figures 6a and 6b, were relatively smooth but showed definite evidence of slowly propagating cracks. The fracture surface of blade H, shown in figure 6c and not visible in figure 4, exhibited severe mechanical damage but no evidence of slowly propagating cracks. The locations of the apparent primary crack origins are indicated by arrows in figures 6a and 6b.

Figure 6. Fracture surfaces of the three fractured compressor blades. Arrows indicate the apparent primary crack origins in 6a and 6b. X 10

a. Blade F.

b. Blade G.

c. Blade H.

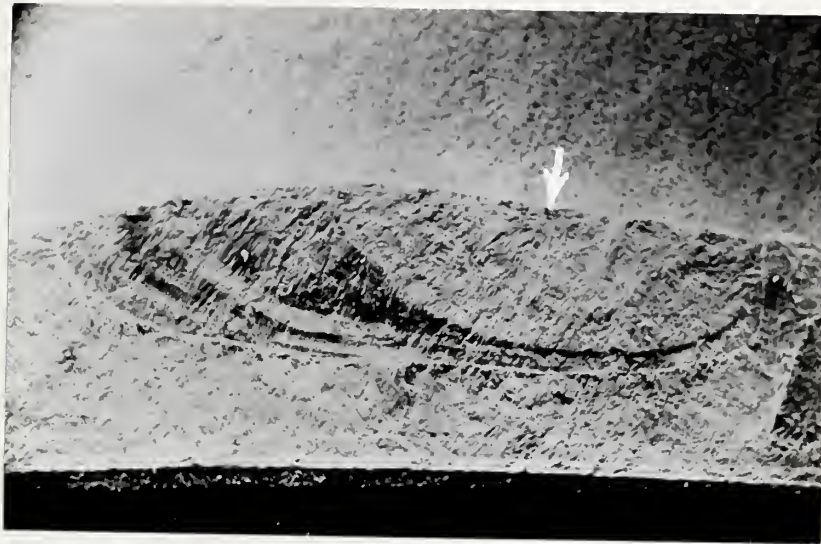
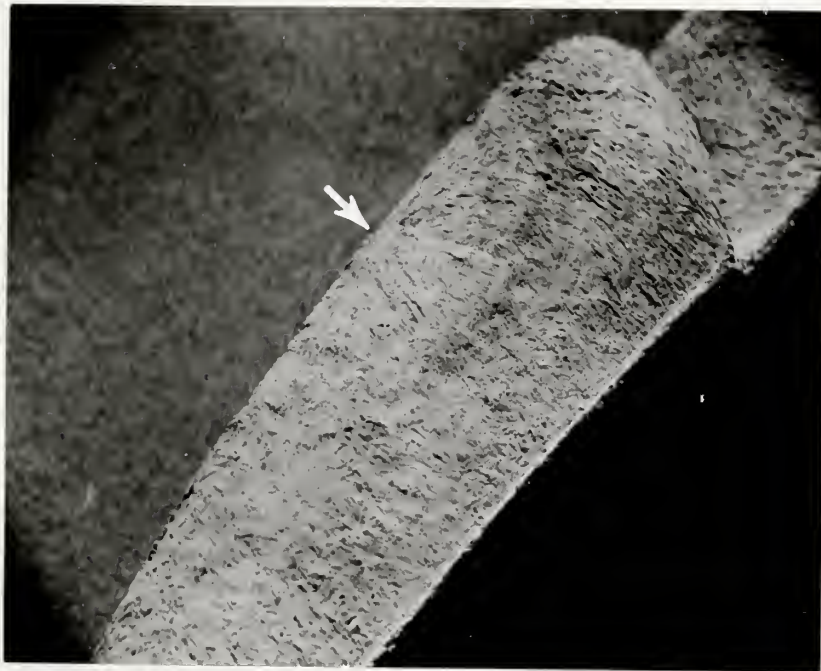
The fracture surface features of blades F and G can be more readily seen, on a macro scale, in the scanning electron photomicrographs (SEM) in figures 7a and 7b, respectively. The apparent primary crack origins are again indicated by arrows. There appears to be a number of crack arrest lines on both fracture surfaces. These are quite evident in figure 7a.

Figure 7. Scanning electron photomicrographs of parts of fracture surfaces. Apparent primary crack origins are indicated by arrows.

- a. Blade F. Crack arrest lines are prominent. X 21.5
- b. Blade G. Crack arrest lines are less evident than in a. X 20

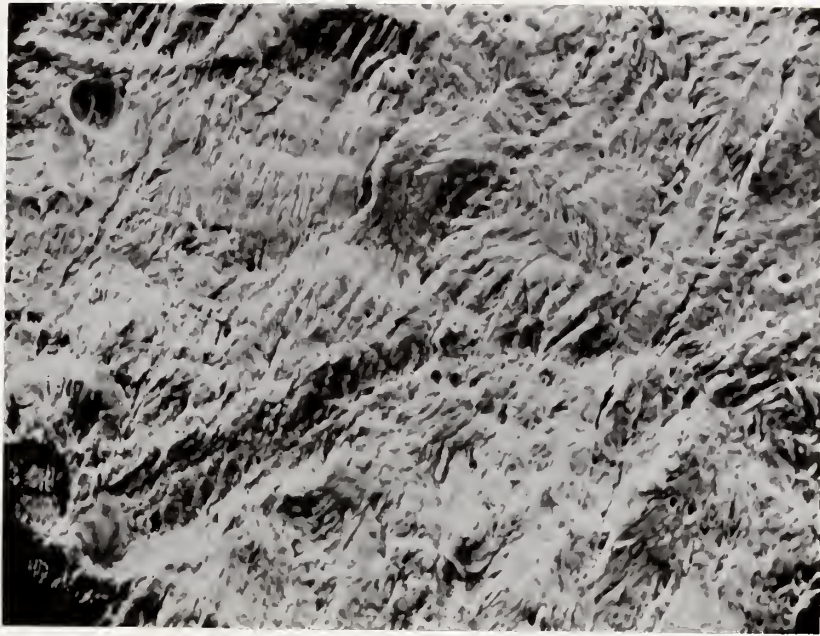
A scanning electron microscope (SEM) examination at higher magnifications revealed evidence of apparent fatigue striations in the slowly propagating regions of the fracture surfaces of both blades F and G. Examples are shown in figures 8 and 9 for blade F, and in figures 10 and 11 for blade G. Features indicating the cast structure can also be seen in these four figures.

Figure 8. SEM of fracture surface of blade F in slowly propagating crack region showing evidence of apparent fatigue striations. X 540

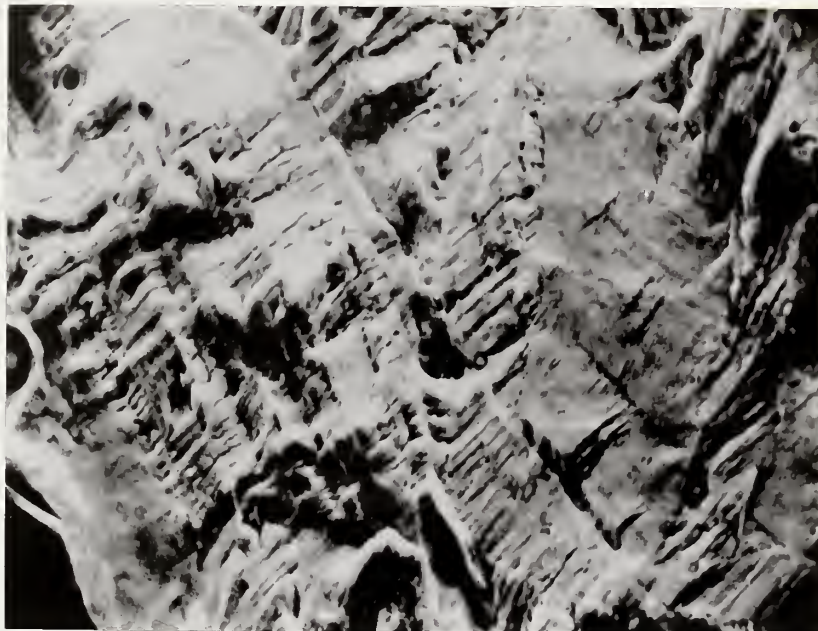
Figure 9. SEM of fracture surface of blade F in slowly propagating crack region showing evidence of apparent fatigue striations. X 2200

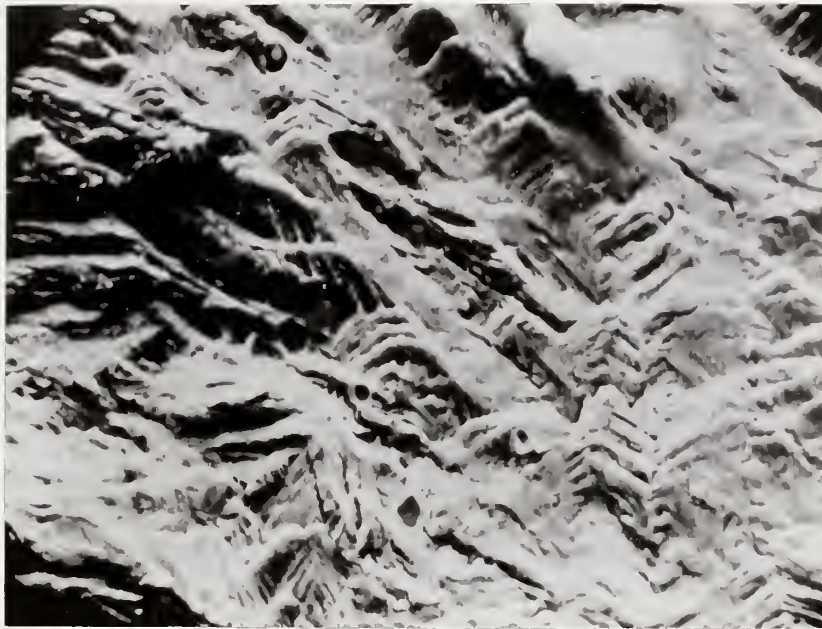
Figure 10. SEM of fracture surface of blade G in slowly propagating crack region showing evidence of apparent fatigue striations. X 1000

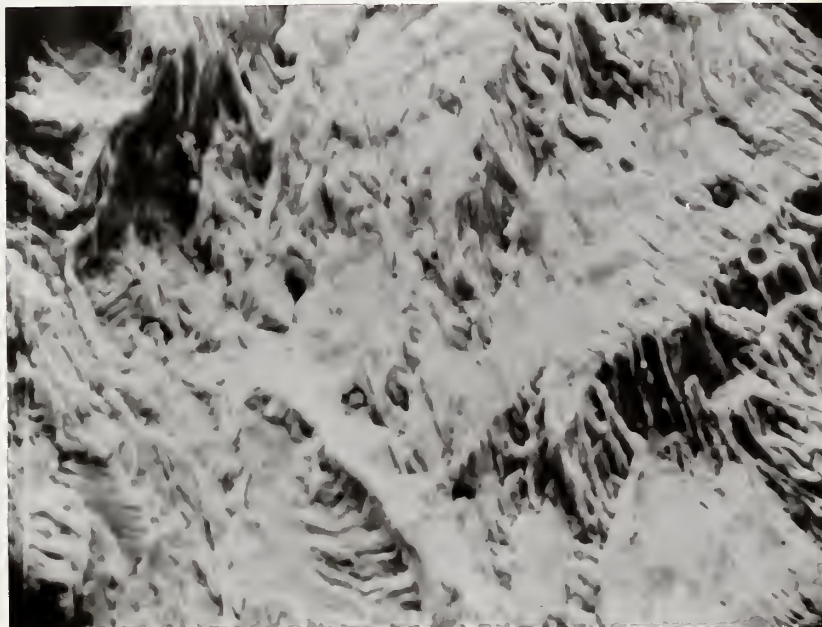
Figure 11. SEM of fracture surface of blade G in slowly propagating crack region showing evidence of apparent fatigue striations. X 1200

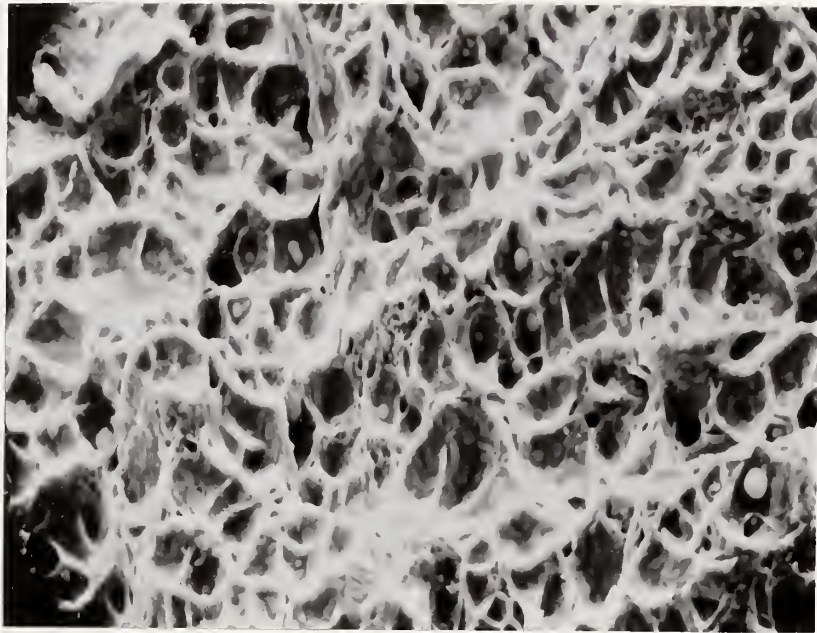
In the overload regions, the fracture surfaces of blades F and G exhibited dimpled rupture. An example of this is shown in figure 12 for the fracture surface of blade F.

Figure 12. SEM in overload region of fracture surface of blade F showing dimpled rupture. X 550

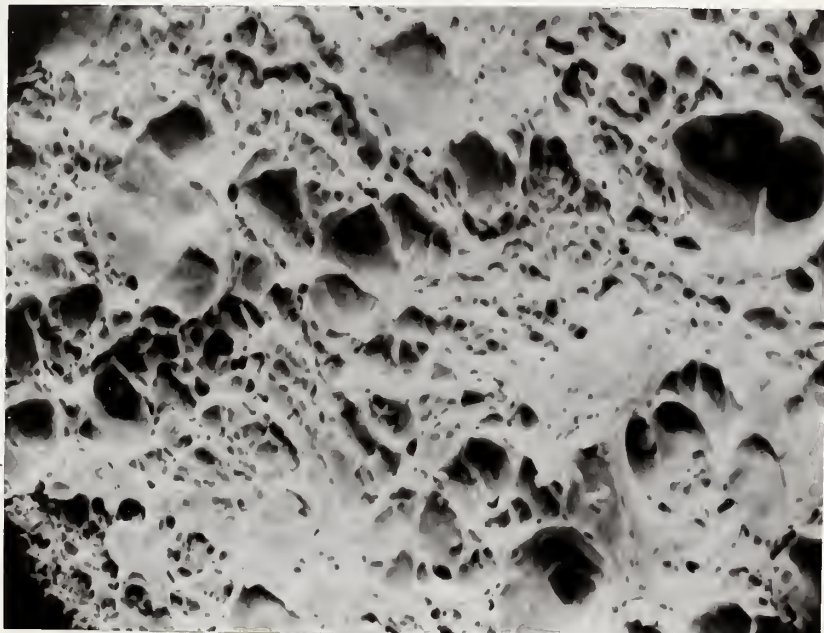
No evidence of a slowly propagating crack was found on the fracture surface of blade H. Although mechanical damage obscured the fracture features in some areas, dimpled rupture was exhibited over most of the fracture surface (figure 13).

Compressor blades F (sixth stage) and G (fifth stage) appear to have failed due to the propagation of fatigue cracks. Compressor blade H (sixth stage) appears to have failed from overload as evidenced by the fracture surface features and the deformation exhibited in the microstructure near the fracture surface. The blade (H) also appeared to have been bent.

Figure 13. SEM of fracture surface of blade H showing dimpled rupture. X 1150

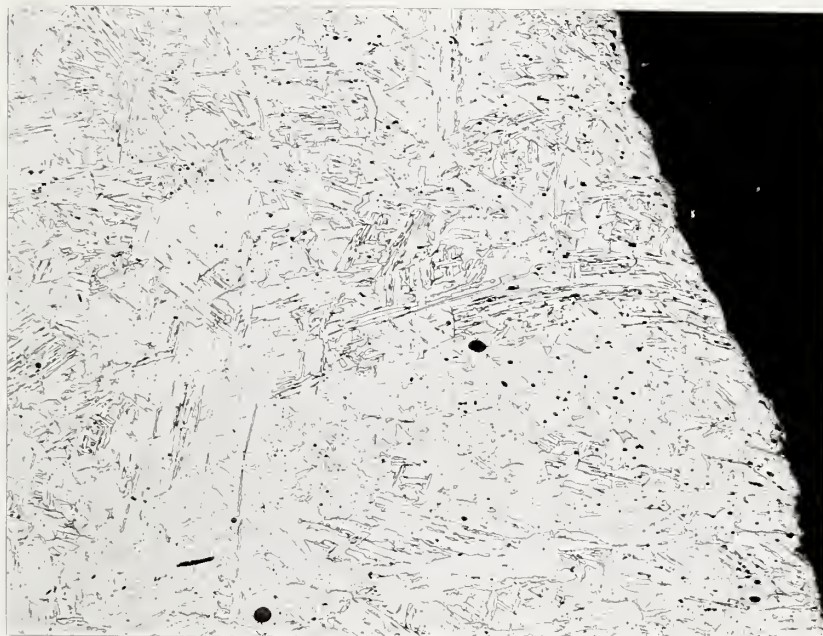
Etched cross sections intersecting the fracture surfaces of each of the three fractured compressor blades are shown in figures 17, 18, and 19 for blades F, G, and H, respectively. Each of the fractures is transgranular in nature. Considerable deformation is exhibited by blade H adjacent to the fracture. Part of the cross section through blade G is shown at a higher magnification in figure 20. The microstructure appears to consist primarily of tempered martensite with stringer-shaped patches of ferrite. This would be the expected microstructure for an austenitized and aged material of the composition specified in AMS Specification 5355B.¹

Figure 19. Etched microstructure of cross section through blade H showing fracture profile at right. Fracture is transgranular and there is considerable deformation adjacent to the fracture. Microstructure consists primarily of tempered martensite and "stringer" shaped areas of ferrite. Etch: Acidified picral. X 100

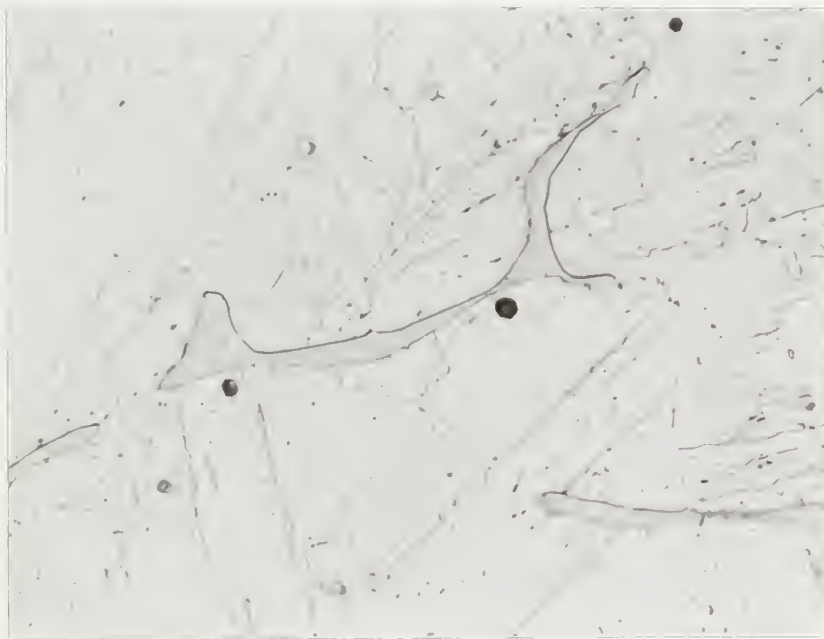
Figure 20. Etched microstructure of cross section through blade G at higher magnification than figures 17 through 19. The elongated "stringer" shaped areas appear to be ferrite. The matrix is tempered martensite. Etch: Acidified picral. X 1000
